# The Esso Longford Gas Plant Accident

## Report of the Longford Royal Commission

## **The Esso Longford Gas Plant Accident Report of the Longford Royal Commission**

**JUNE 1999**

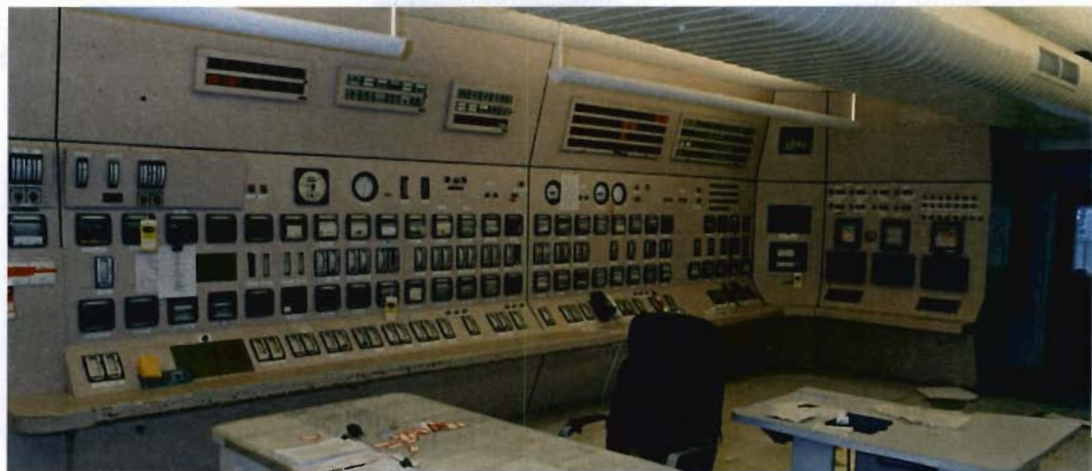
***Figure 2.13 Photograph of GPI Pneumatic Control Panel  
(taken after the Bailey equipment was removed for examination)***

- 2.26 The pneumatic equipment and associated alarms were mounted on panels around the walls of the control room. They can be seen in Figure 2.13, a photograph taken after the accident of 25 September 1998. The primary pneumatic instruments were controllers that enabled the operators to set the value of the process variable that they wished to control. This was done by moving a red pointer to the appropriate setpoint on the right-hand side of a vertical scale (see Figure 2.14). When the controllers were in operation, a black pointer moved up the left-hand side of the controller to indicate the actual value of the process variable being controlled. When the process was being effectively controlled the black and red pointers would be aligned, making it easy to see whether it was operating properly. An example of this alignment may be seen in Figure 2.14.

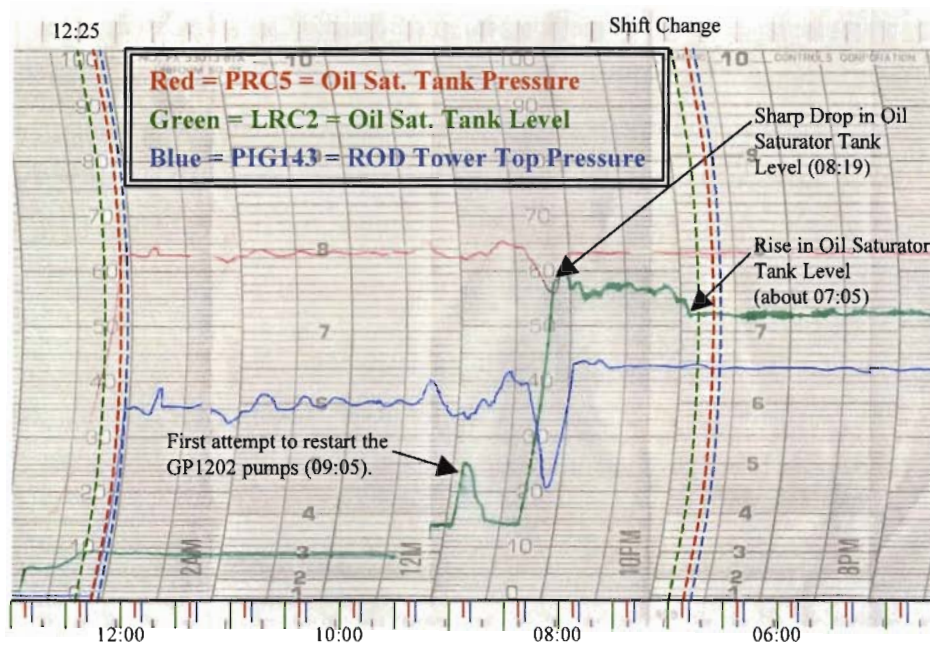
**Figure 3.1 Strip chart showing the rise and sharp fall in the LRC2 Oil Saturator Tank level**

condensate entered the rich oil stream causing that stream to flash more than usual on its way to the Rich Oil Flash Tank, GP1108, and to drop in temperature. A number of unusual events in the ROD/ROF area occurred after the condensate level in Absorber B became high. These were directly related to the lower than normal temperature in GP1108, and the lighter than normal composition of its contents. The most probable reasons for these events occurring are discussed later in Chapter 5. The first of these events was a rise in the level of the Oil Saturator Tank GP1110, which can be seen on the relevant strip chart (see Figure 3.1) from just after 7.00 am to about 8.19 am when the level fell sharply. The additional liquid flow causing this rise in level would appear to have come through the pipe from the top of the ROD tower, which was the path normally taken by the methane used to presaturate the lean oil flowing to the Oil Saturator Tank. The rise in level demonstrates that there was an upset in the ROD at this time. (This is discussed in more detail in Chapter 5.)

3.5 A consequence of the rise in the level of the Oil Saturator Tank was that LRC2 closed the valve regulating the flow from the GP1201 pumps. This reduction in flow would have caused LFSD8 to shut down the GP1201 pumps. With the shutdown of the GP1201 pumps, the level in the Oil Saturator Tank would have fallen rapidly as the GP1202 pump delivered the contents to the absorbers and ROD reflux. GP1202 was protected against running dry by a shutdown switch that was triggered by a low level in the Oil Saturator Tank. Following the fall in the level of the Oil Saturator Tank, the strip chart shows that the level steadied out

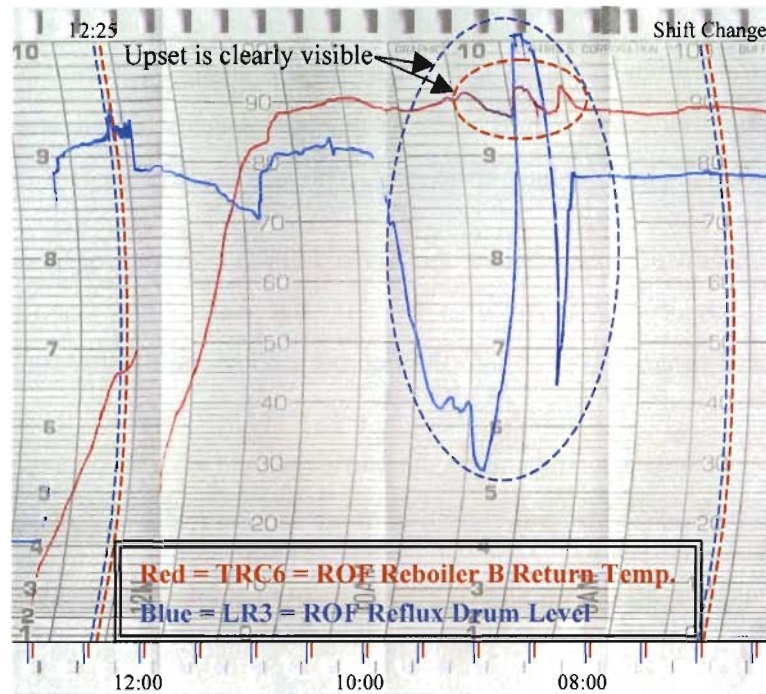
*Figure 3.2 ROF strip chart showing upset*

- 3.9 Following the cessation of lean oil flow, the condensate flowing from the absorbers through the rich oil system was flashing at lower and lower temperatures with the result that there was a drop in temperature in the Rich Oil Flash Tank and the ROD system. Indeed, the absence of any lean oil flow to the heat exchangers GP904, GP924, GP925 and GP930 meant that the condensate flowing through the rich oil system was not warmed before it reached the ROD, GP905 and GP922. Simulations indicate that the temperature reached as low as -48°C in this section of the plant. This cold flow caused an upset on entering the ROF. The ROF ceased to boil and there was a much reduced flow of vapour from the top of the ROF. This upset is clearly visible on the ROF strip charts. This in turn caused a

reduction in level in the ROF Reflux Accumulator so that the panel operator thought that the reflux pump, GP1203, had shut down. (See Figure 3.2). That pump delivered reflux back to the top of the ROF. Attention was diverted from the attempts to restart the GP1201 pumps when the area operator was asked to check the situation of GP1203.

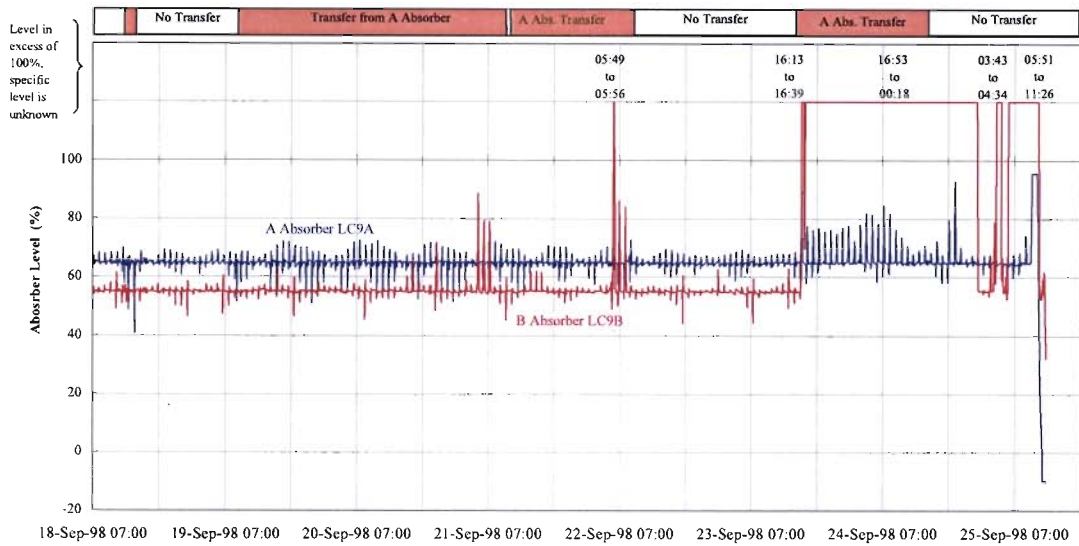
Figure 5.1 Absorber condensate levels 18 to 25 September 1998

- 5.5 The levels of condensate in the bottom of both absorbers in the week preceding 25 September are shown in Figure 5.1. For half the night shift commencing on 24 September, condensate levels in Absorber B were above the 100% level and were at that level from 5.51 am until the end of the shift. After the shift change, the levels in Absorber B stayed above 100% until 11.26 am by which time there had been no inlet gas feed to GP1 for about 15 minutes.

- 5.9 As shown in Figure 5.1, at the shift change on 25 September, condensate levels in Absorber B had been over 100%, the highest recordable level, for 33 of the preceding 38 hours. This provided ample opportunity for condensate to carry up into the rich oil tray in Absorber B and to dilute the rich oil progressively. As discussed in paragraph 5.2, the gas entry in the bottom of the absorbers was conducive to such a carryover even when condensate levels were significantly below the rich oil tray. This tendency must necessarily have increased with high levels of condensate.

- 13.119 The practice of operating the absorbers in alarm occurred not only through the preceding night shift, but over a number of shifts in the days leading up to the accident on 25 September 1998. This was readily apparent from the PIDAS records (see Figure 5.1) and from the alarm log data.

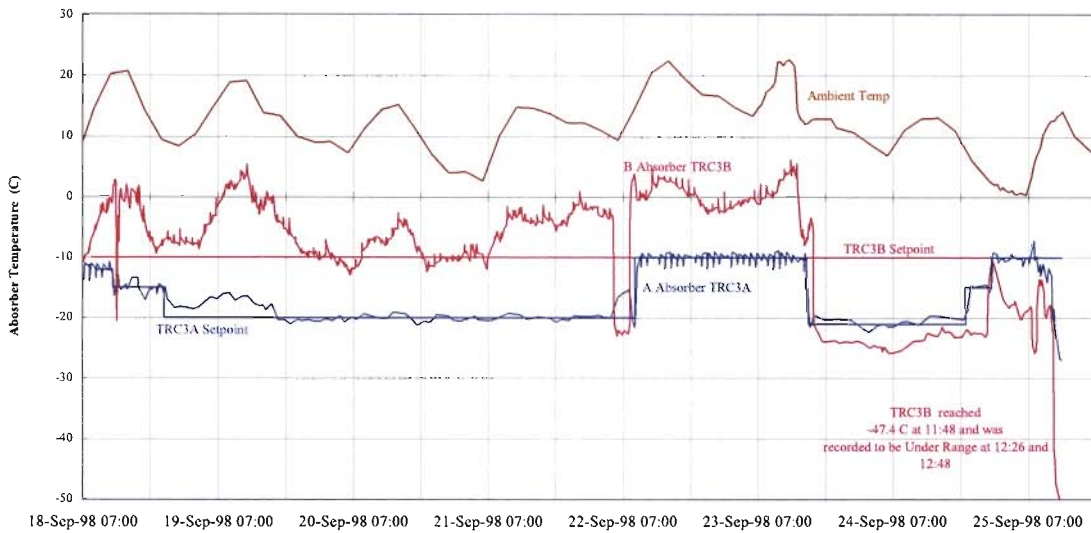
Figure 5.2 Absorber condensate temperatures 18 to 25 September 1998

- 5.6 The condensate temperatures at the base of the absorbers are illustrated in Figure 5.2. Condensate temperatures in Absorber A were automatically controlled close to -10°C during the night shift. However, the temperature of the condensate in Absorber B at shift change was about -18.5°C, having recovered from -20°C at about 5.30 am. It was the practice to set the temperature in an absorber to -20°C when it was delivering condensate to GP2, but this was not the case on 25 September. The appropriate setpoint was -10°C for both absorbers.

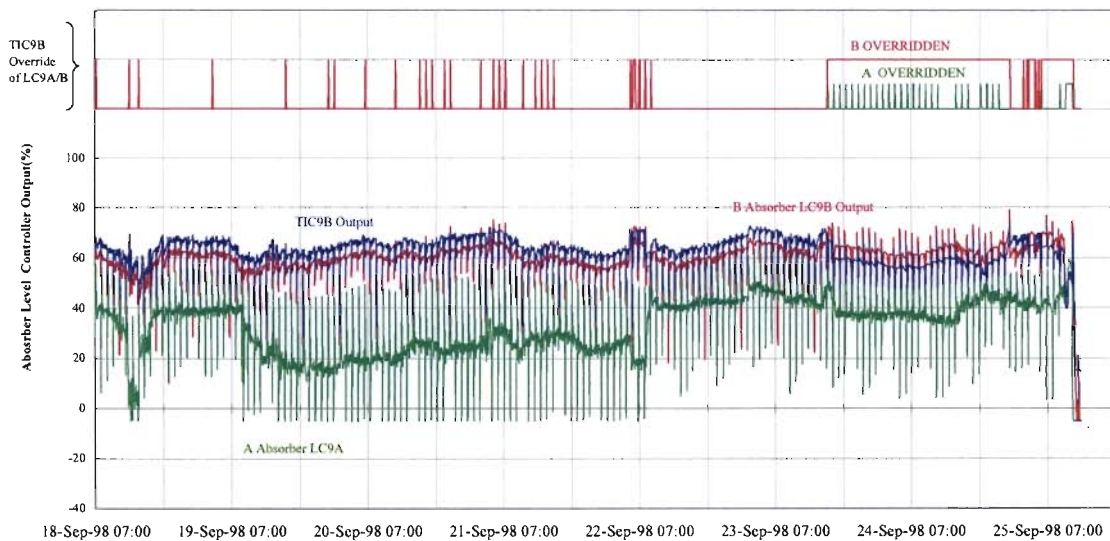
Figure 5.3 Absorber level overrides 18 to 25 September 1998

- 5.8 Figure 5.3 shows that TC9B was overriding LC9B continuously for the first five and a half hours of the night shift. The override then became intermittent. From 6.00 am onwards it was continuous. In this situation, the level of condensate was not controlled and would have varied depending on the balance between incoming and outgoing condensate. At certain times during the night shift starting on 24 September, the flow of incoming condensate exceeded the flow leaving, resulting in the condensate level rising rapidly until it was above the level that could be measured. It was then impossible for the operator to observe the actual level of condensate or any flow of condensate into the rich oil system.

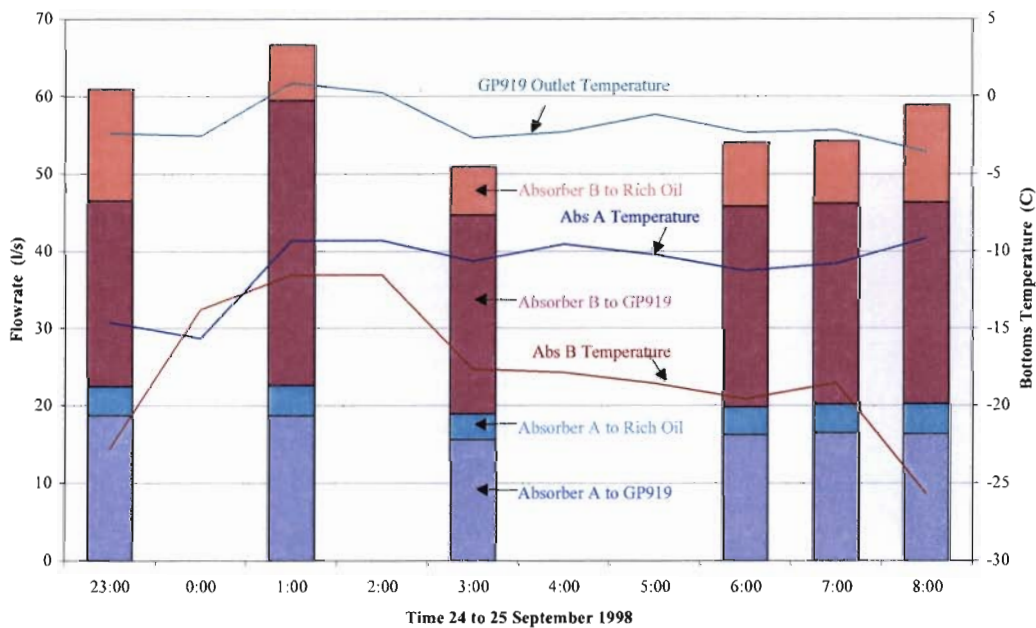
Figure 5.4 Estimated condensate flows 24 to 25 September 1998

5.10 The flowrates of condensate entering the rich oil stream at different times between 11.00 pm on 24 September and 8.00 am on 25 September were estimated using the computer simulation (Figure 5.4). The bars in the figure show the flowrate of condensate leaving each absorber via GP919 and the rich oil stream. The line graphs show the corresponding absorber temperatures. It should be noted that these calculations show these conditions assuming that stable operation was achieved at the input conditions prevailing at that time. Time delays in the gas and liquid streams, and the complex dynamics of the various recycle loops feeding the absorbers, have not been quantified. This simplified analysis indicates that the flow of condensate into the rich oil stream peaked at 11.00 pm on 24 September and again at about 8.00 am on 25 September. Although at 6.00 am the inlet gas flow was higher, and the ambient temperature lower, the incoming condensate flow was also lower and it does not appear that the conditions at that time were more severe than at 11.00 pm on 24 September.

5.26 Another possible sudden change that could have influenced the ROD was the decision by Ward at 7.30 am to close the TRC3B bypass valve. This would have resulted in a significant increase in condensate flowrate into the rich oil stream. The simulation verified this (Figure 5.4). However, the change in temperature, indicated by TRC3B, also occurred too late to be the initiator of the disturbance in the level indicated by LRC2 which was first seen at 7.03 am.

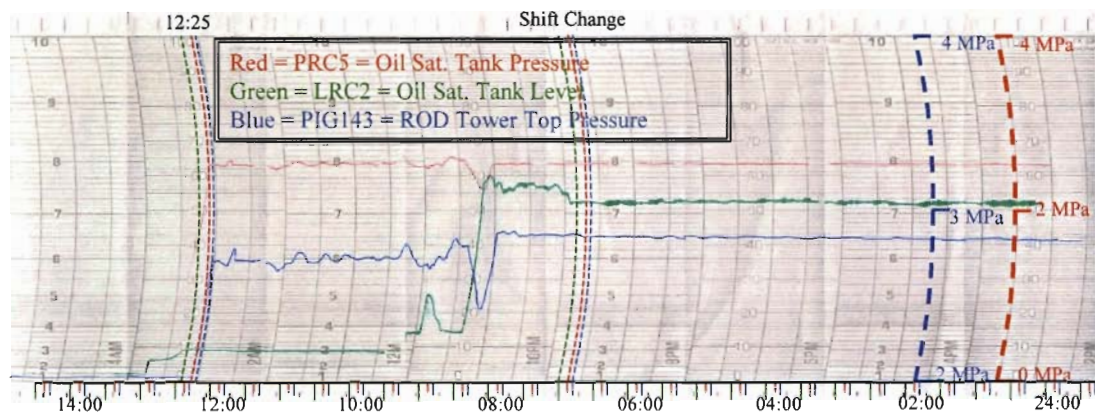
***Figure 5.5 Oil Saturator Tank level and pressure***

5.12 At the time of the shift change, the first visible signs of a process upset in the ROD/ROF area started to appear on those chart recorders that were operational. Earlier indications may have been visible to the operators. At 7.03 am the level started to rise on the Oil Saturator Tank as shown by level recorder, LRC2, and by 7.30 am it was significantly above its setpoint (Figure 5.5). Had all the installed chart recorders been operational, diagnosing the cause of this rise would have been straightforward. Unfortunately, the chart recorders measuring two of the important flows were not working. The cause of the level increase would therefore not have been readily apparent to the operators on the day. It has been necessary to deduce the cause of this rise in level from calculations based on those charts that were available, and knowledge of the physical behaviour of the system.

- 5.24 The initial decrease in level at about 8.20 am is thought to have been due to the ramp down in ROD pressure when the GP1201 pumps tripped (Figure 5.5). Controller LRC1 controlled the warm feed to the ROD whereas the flowrate of the cold feed was fixed by flow controller FRC9 (Figure 5.12). The pressure drop across the control valve LRC1 would have increased as the ROD pressure dropped. The flow through the control valve would then have increased too quickly for the LRC1 controller to compensate, and the level would have started to drop. Until 8.29 am, flows continued into and out of the Rich Oil Flash Tank. When the GP1202 pumps tripped at 8.29 am, the flow of rich oil into the Rich Oil Flash Tank ceased and the level dropped more rapidly. This drop in level was due to the continuing flow of cold feed to the ROD through FRC9 and was suddenly arrested when the low temperature shutdown switch, LTSD1, closed the FRC9 control valve in the cold feed line. The calculated rate of heat input through the insulation from the surroundings indicated that LTSD1 would have reset after a time delay of between one and one and a half hours. Some of the later disturbances in the trace are therefore thought to correspond to alternate resetting and tripping of the cold feed trip LTSD1. Matching other features on the chart to those on other charts gives confidence in the timing ascribed to the chart and is consistent with this explanation.

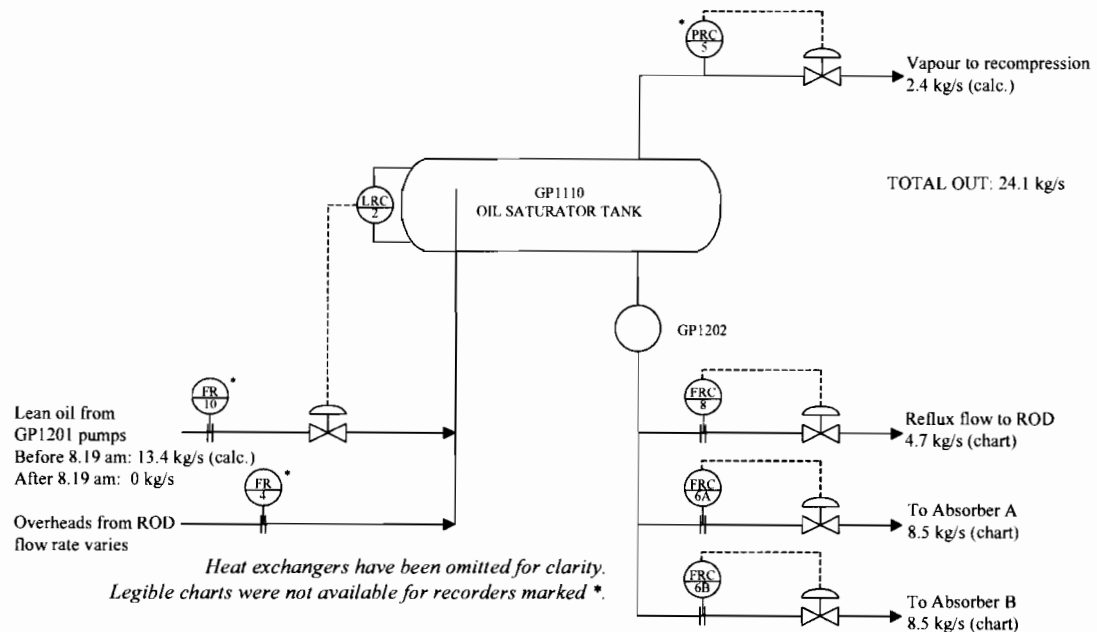
**Figure 5.6 Flows into and out of the Oil Saturator Tank**

5.13 The flows into and out of the Oil Saturator Tank are shown in Figure 5.6. The liquid flow out of the Oil Saturator Tank remained steady at this time, as measured on three of the operating chart recorders. The level increase must therefore have been due to an increase in flow entering the tank. Unfortunately, neither of the two recorders on the incoming streams (FR4 and FR10) were working, so the inlet flows had to be calculated. LRC2 controlled the level in the tank by adjusting the lean oil flow into it, and had been operating effectively up until that time. No fault was found with the LRC2 level transmitter, controller or recorder

5.15 The only other source of flow into the Oil Saturator Tank was the overhead line from the ROD (Figure 5.6). It would appear that a higher than normal flow into the Oil Saturator Tank from the top of the ROD must have occurred, which resulted in LRC2 reducing the incoming flow of lean oil. Once LRC2 had closed its control valve as far as possible, it could have done no more to hold the level steady. Continuation of the increased inflow would have resulted in the level increasing above its setpoint, as observed at 7.03 am.

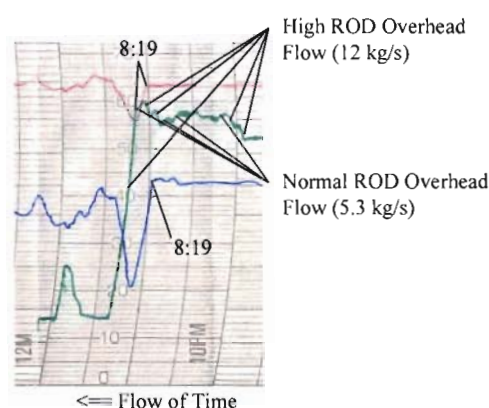
**Figure 5.7 Enlargement of LRC2 trace**

5.16 Calculations based on the observed rate of level increase show that the total flow from the top of the ROD at this time was approximately 12 kg/s (equivalent to 840 l/min of condensed liquid), assuming that the control valve for LRC2 was at its minimum position

(Figure 5.7). The flow through the control valve was calculated from knowledge of its measured minimum opening when tested, and the system pressures, pump curves and piping configuration. The decreases in level on the same chart correspond to periods of normal vapour flow from the top of the ROD. After the GP1201 pumps stopped at 8.19 am, the rate of decrease also corresponds to an inflow of around 12 kg/s. Therefore this trace is consistent with intermittent high flows of material from the top of the ROD. The observed flowrate is approximately twice the normal vapour flow from the top of the ROD, calculated as 5.3 kg/s. The flow of lean oil to the top of the ROD was measured by FRC8 as 4.7 kg/s. The 12 kg/s overhead flow is therefore somewhat more than the sum of the normal vapour flow and the reflux flow.

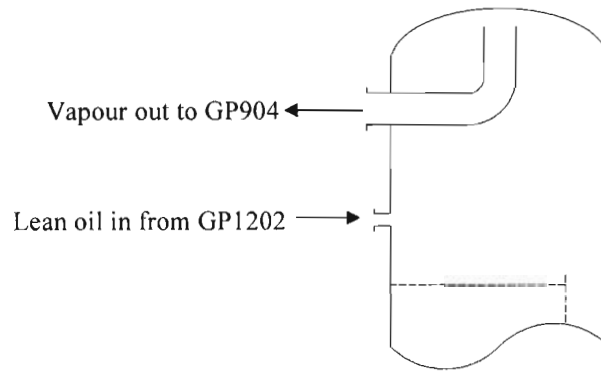
**Figure 5.8 ROD vapour outlet connection**

- 5.17 One possible mechanism to explain this is so called “flooding” of the top section of the column. If the flow of vapour rising through a distillation column is excessive, the resulting pressure can prevent liquid flowing freely down the column. This liquid then builds up and will leave by the overhead vapour line, until the downward flow can again be restored. The ROD column does not appear from the drawings to have been fitted with a mist eliminator, which is designed to coalesce small liquid droplets and stop them leaving with the overhead vapour. The outlet connection pointed upward (Figure 5.8) so as to minimise the possibility of liquid slugs entering the vapour line. Although such a design would reduce the impact of some types of liquid carryover, entrainment of small droplets or gross flooding of the top trays could have still allowed liquid to enter the vapour product line.

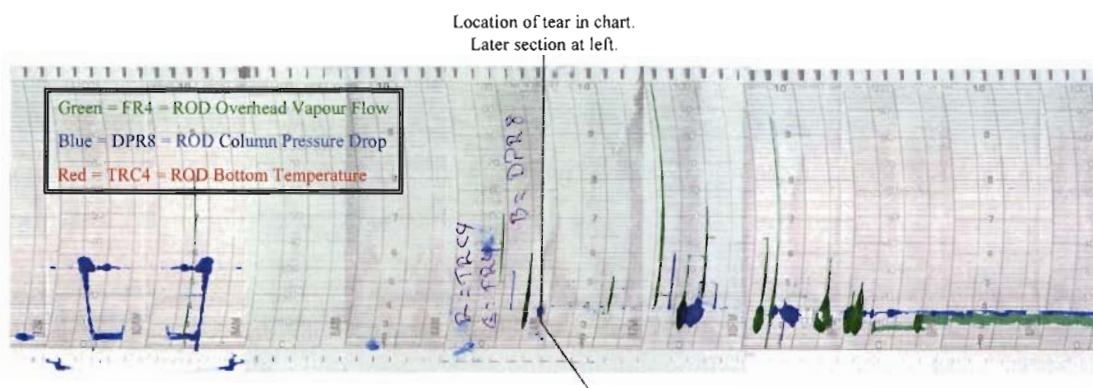
**Figure 5.9 Chart recording of ROD overhead flow (FR4), ROD differential pressure (DPR8) and ROD bottom temperature (TRC4), for which no record is visible**

5.18 Direct evidence of flooding actually occurring on the morning of 25 September is not available, as the chart recorder for the vapour flow (FR4) was not working. The drive motor was not advancing the chart paper. The same chart (Figure 5.9) also recorded the differential pressure across the ROD (DPR8), a useful indicator of flooding, and the ROD bottoms temperature (TRC4). There is some indication of higher than normal vapour flows and column pressure drops, but the timing of these cannot be determined. The TRC4 trace is not visible. Clearly this chart is of limited use when investigating the events leading up to the accident. A flooding column results in a highly distinctive chart trace, but is difficult to detect from spot indicator readings alone. The poor state of such a critical recorder chart would have made troubleshooting of the ROD column operation virtually impossible from the time that the chart drive failed. As the paper had been wound on at various times, it appears that the operators had used the chart, but the time at which it failed is unclear.

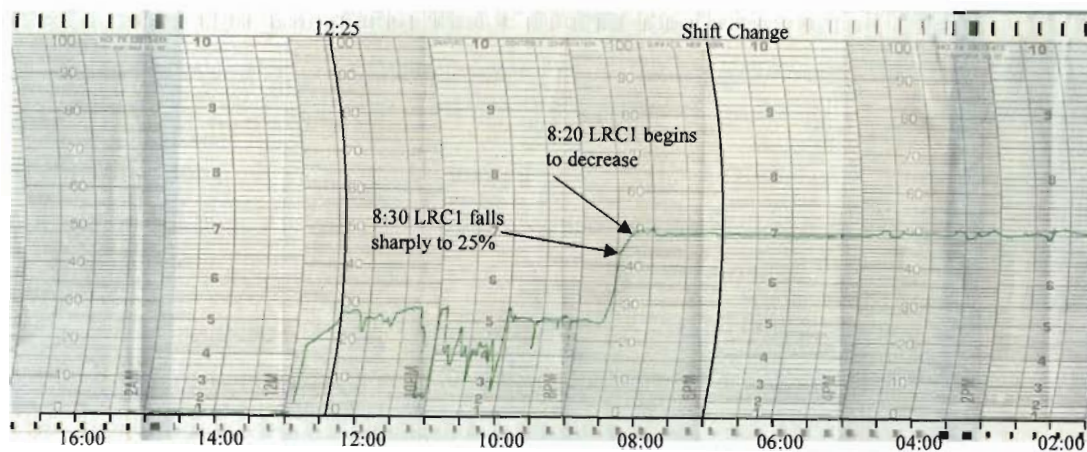
*Figure 5.10 Chart recording of Rich Oil Flash Tank level (LRC1)*

- 5.22 A sudden change in the feed flowrate to the ROD could also have precipitated flooding. One such potential change is a sudden decrease in the setpoint of LRC1. Indeed, the setpoint was found to be at 57% after the accident, rather than the 50% expected if it had been left unchanged. A sudden decrease in setpoint would have caused the control valve in the warm feed line to the ROD to have opened rapidly. The level in the Rich Oil Flash Tank did decrease rapidly starting at about 8.20 am (Figure 5.10). Clearly this was too late to be the initiator of the disturbance observed in LRC2 at 7.03 am.

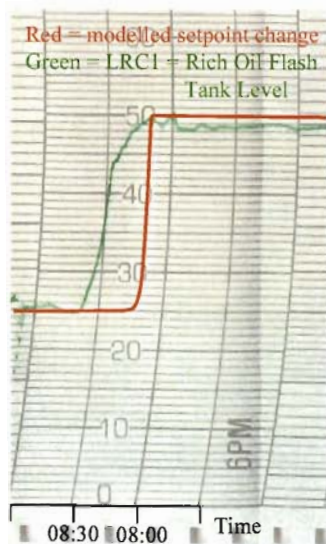
*Figure 5.11 Simulated LRC1 setpoint change*

- 5.23 At first sight it appears possible that the drop in LRC1 could have been caused by a change in setpoint. However the panel operator Ward denies making such a change and there appears to have been little reason for him to have done so. The shape of the trace is also contrary to that expected from a change in setpoint, as indicated by the dynamic simulation results shown in Figure 5.11. This simulation used the tested dynamic response of the controller LRC1. This response clearly differs from that observed and supports the view that the level change was not due to a change in setpoint.

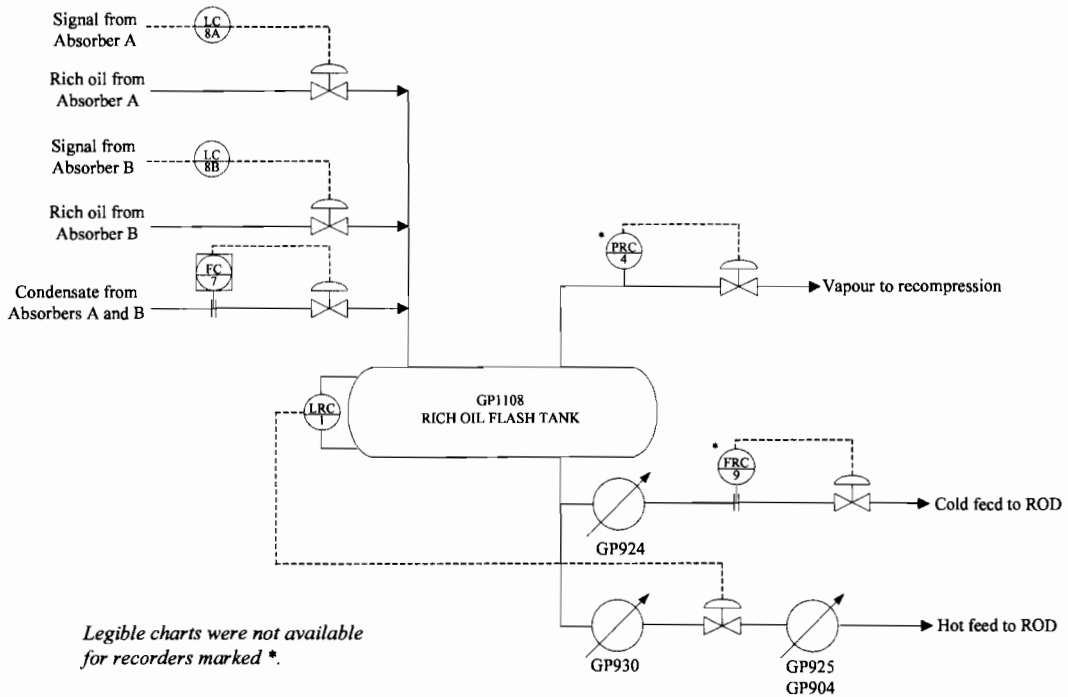
**Figure 5.12 Flows into and out of the Rich Oil Flash Tank**

- 5.25 Although a setpoint change to LRC1 remains a possibility, on the evidence available it appears less likely than the above explanation. Such a setpoint change would have resulted in a significant upset to the ROD that could have resulted in carryover or flooding. However, it would have occurred at least one hour after the initial signs of carryover were observed, and so cannot explain the earlier rise indicated by LRC2.

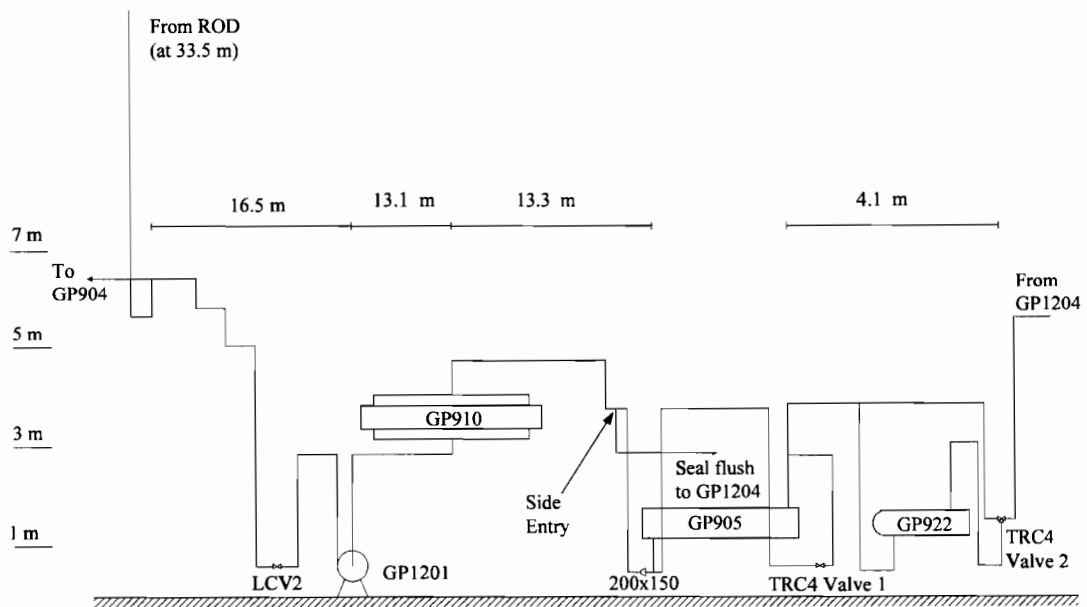
**Figure 5.14 Lean oil piping elevation**

In order to start a pump, sufficient liquid must flow into its suction to enable it to prime. The GP1201 pumps were provided with bleed lines to enable small amounts of vapour to be bled from the pump casing to help this. However, this would not have been sufficient if the vapour backflow were continuing or most of the liquid had already been pushed out of the suction line. Two-phase flow calculations showed that the calculated vapour backflow was sufficient to displace all liquid from downward sloping piping. However, the vapour would not have displaced the liquid from the vertical piping legs, but instead would have bubbled through it. The lean oil piping contained many up and down legs (Figure 5.14). In particular, the GP1201 pumps were at one low point in the line and the GP910 cooler was at an adjacent high point. This means that when vapour flowed backwards through the GP1201 pumps it would have displaced most liquid in the discharge line and in the pumps themselves. On the suction side, however, the vapour flow would have supported liquid in the vertical leg and in the GP910 cooler. If the vapour flow were interrupted, this liquid would have fallen back into the pump suction and enabled the pump to start. If more pockets of vapour were drawn into the pump, or through the LFSD8 flow sensor, the pump would then have stopped again. The back flow of vapour could have been interrupted either by closing a block valve on the GP1201A pump, or by the reseating of the check valve, for example, during one of the restart attempts.

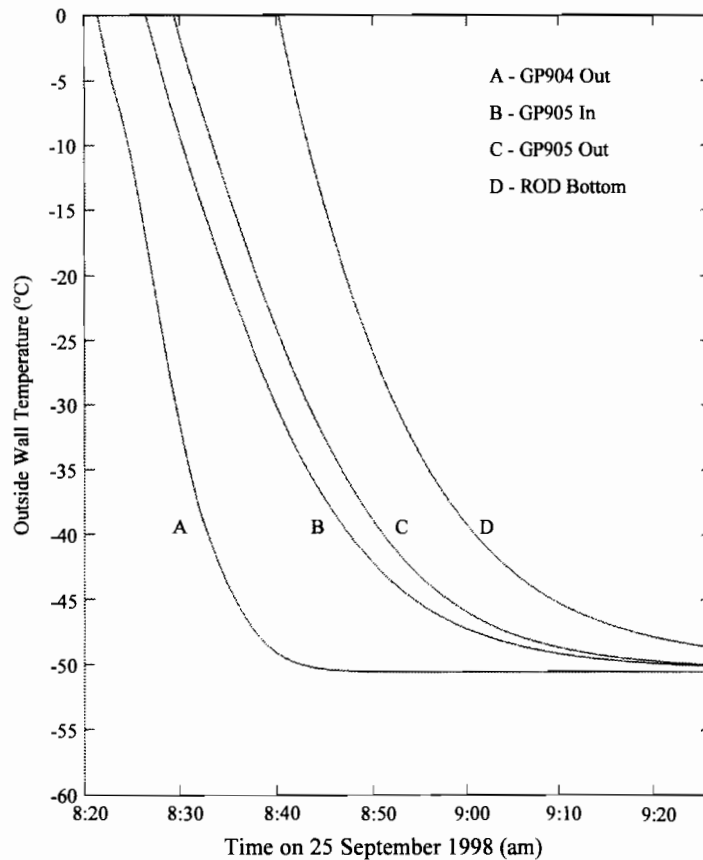
**Figure 5.15 Thermal response of GP904, GP905 and ROD following loss of lean oil**

5.49 Before the shutdown of the GP1201 and GP1202 pumps, the temperature in the Rich Oil Flash Tank was about -33°C. After the pumps stopped, the contents of the Rich Oil Flash Tank cooled down rapidly to -42°C and both feeds to the ROD cooled to -48°C. The dynamic modelling of the system shows that within half an hour the entire ROD, including its feed piping, and GP905 were at -20°C and after an hour had cooled to -48°C (Figure 5.15). They remained at about this temperature for the rest of the morning.

5.50 The results in Figure 5.15 are conservative and assume that the high level in Absorber B was not sufficient for the direct overflow of condensate into the rich oil trap tray. If the condensate continued to overflow after 8.30 am, the times in Figure 5.15 could be as little as half those indicated.

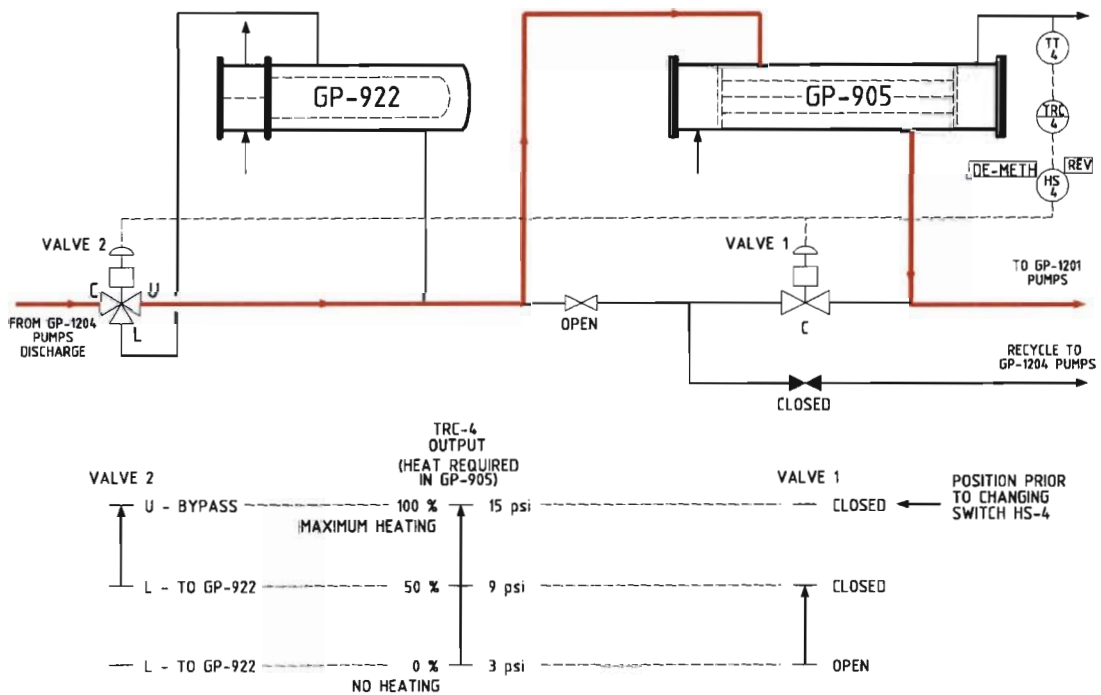
Figure 5.16 Flow path prior to changing HS4 from demethaniser mode

5.57 With the very low temperatures in the bottom of the ROD tower at this time, the output of the TRC4 controller would have been 100% (15 psi). In this condition, and with HS4 in its normal position for demethaniser mode, the two control valves would have been set for the flow path shown in Figure 5.16. Changing the switch to de-ethaniser mode would then have changed the flow path to that shown in Figure 5.17. As a result, lean oil would have bypassed both heat exchangers, although a small flow would still have passed through GP905, provided that at least one GP1201 pump was operating.

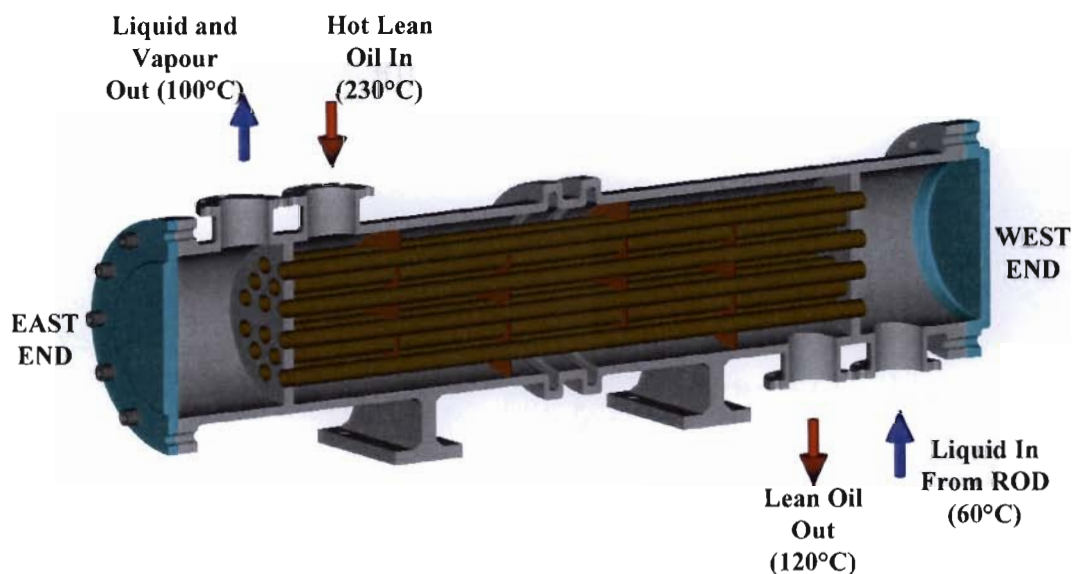
*Figure 6.1 Schematic view of the GP905 Reboiler*

- 6.1 The GP905 reboiler was a single tube-pass shell and tube heat exchanger. See Figure 6.1. Cold ROD tower liquid (demethanised rich oil) entered the channel at the west end and was heated, by the hot lean oil on the shell side, as it passed through the tubes to the east end. It left the east end channel as a mixture of warm liquid and vapour, and returned to the bottom of the ROD. The hot lean oil entered the reboiler's shell at the east end and was cooled as it flowed round the baffles to the west end. It flowed in the opposite direction to the liquid in the tubes. The temperatures marked on Figure 6.1 were typical of those for normal plant operations. They are not the temperatures existing on 25 September 1998.

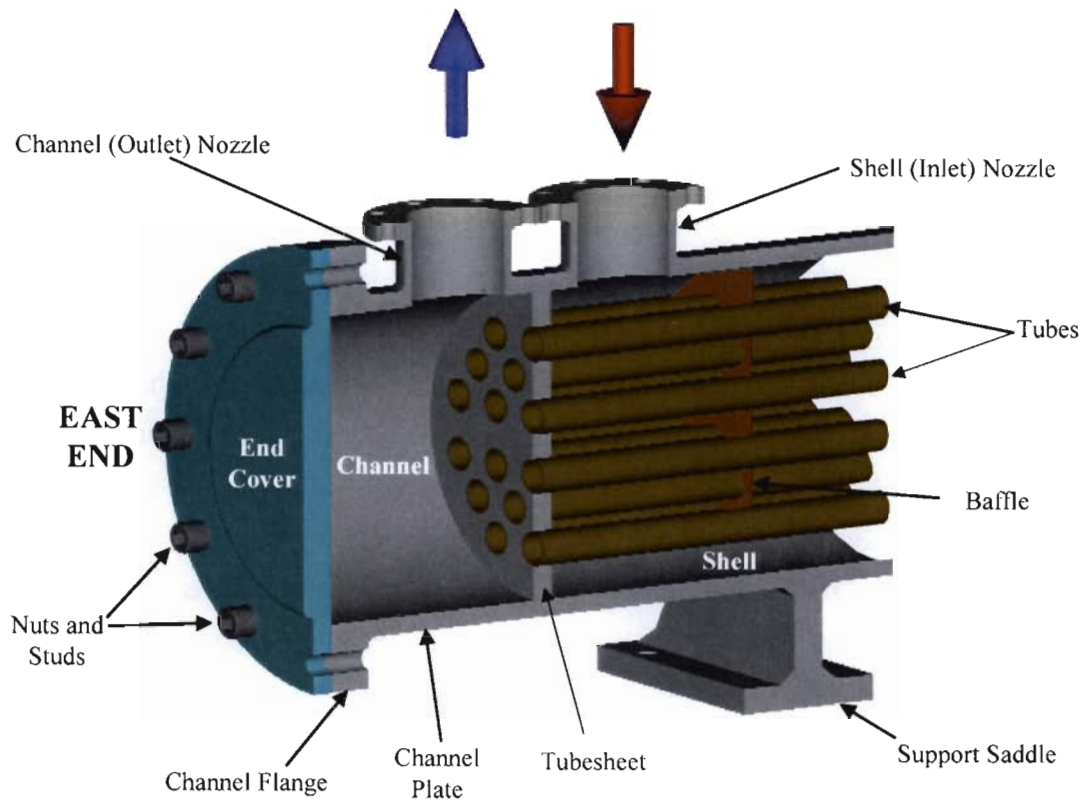
*Figure 6.2 Naming convention used for exchanger parts*

- 6.2 The different parts of an exchanger have specific names. These are shown in Figure 6.2.
- 6.3 Figure 6.3 provides details of the welds that attached the reboiler's shell to its tubesheet and its tubesheet to its channel. The figure also provides details the reboiler's nozzles.

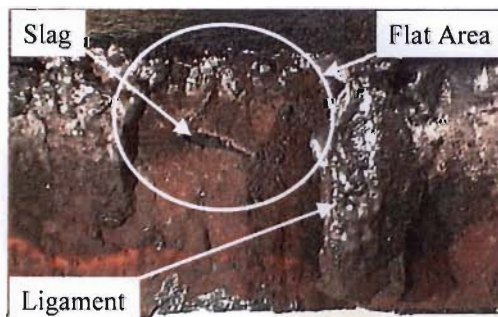
**Figure 6.13 Close-up of the 8 o'clock position (before cleaning the surface)**

6.16 The scanning electron microscope revealed non-metallic inclusions scattered within the 8 o'clock area. On detailed examination of the surface, a large slag inclusion (measuring 5 mm by 1 mm) can be seen in the middle of the flat region. Figure 6.13 and Figure 6.14 are photographs of the surface at the 8 o'clock position before and after cleaning. The slag inclusion is clearly visible. X-ray analysis confirmed the inclusion to be welding slag.

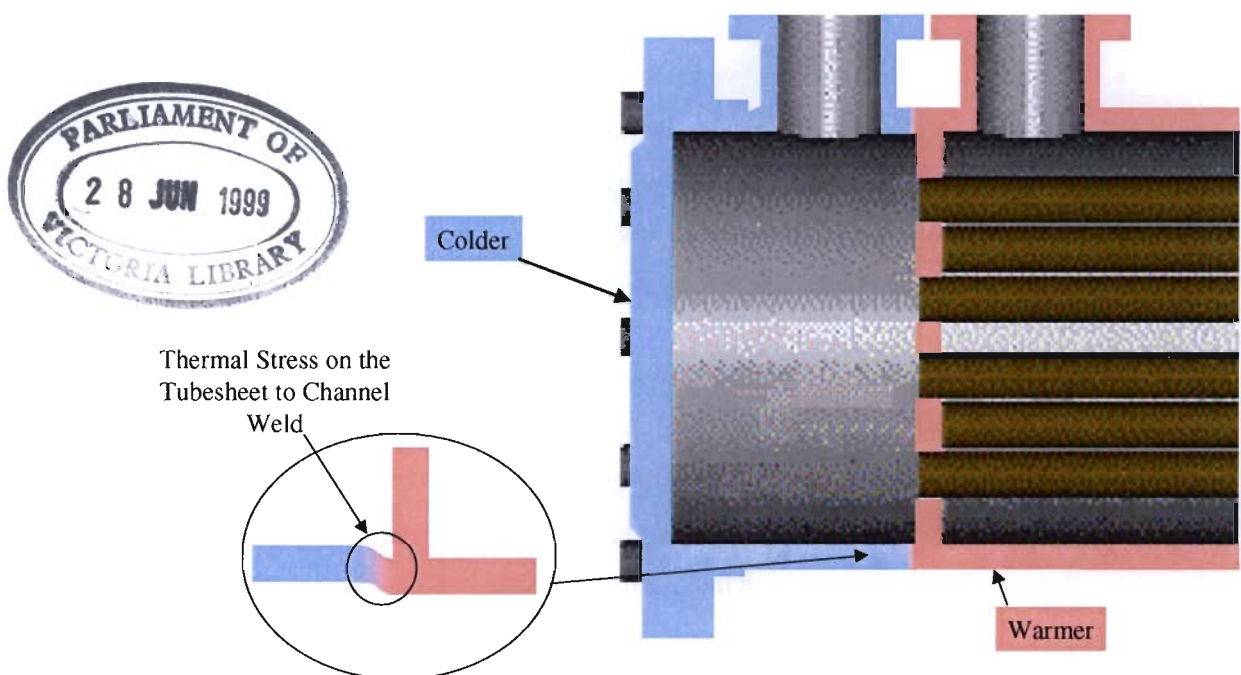
*Figure 6.18 Finite element model for GP905 thermal stress calculations*

stresses. A temperature difference of the order of 20°C would have been sufficient to result in the failure on 25 September 1998.

6.26 The modelling method used was finite element analysis. The model calculated the stress in the tubesheet to channel weld due to the stresses induced by the internal pressure and a temperature differential between the channel and the shell. The residual stresses were ignored, as they were small in comparison. The model accepted the shell side being uniformly warmer than the channel of the reboiler, as shown in Figure 6.18. The temperature difference would cause the shell side to expand to a larger diameter than the channel, resulting in stress in the tubesheet to channel weld.

6.27 The model calculated the axial stresses for the internal pressure and the 1°C temperature difference in the tubesheet to channel weld. The initial model was enhanced to a 3D model that evaluated the effects of the nozzles on the stress. The nozzles were found to have little effect on the stresses in the tubesheet to channel weld.

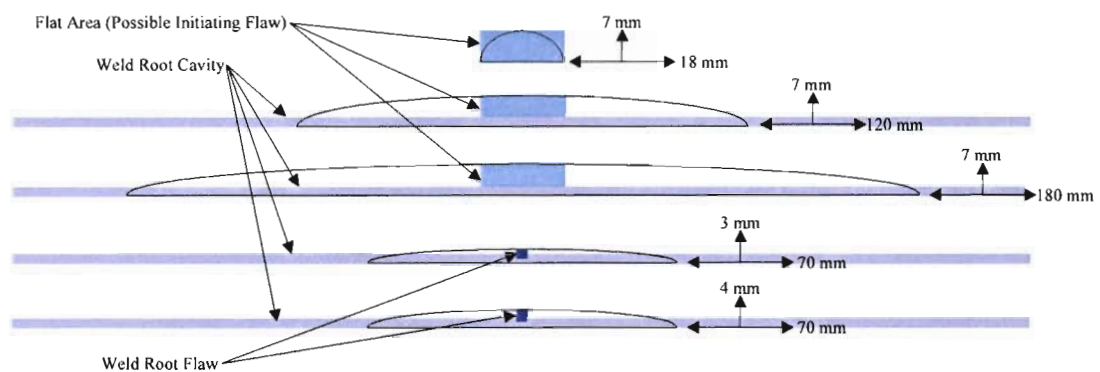
Figure 6.19 Flaw cases for 3D modelling

- A combination of a flaw the size of the flat region and the weld root cavity. This was modelled as a semi-elliptical flaw 180 mm long by 7 mm deep. The weld cavity was 230 mm long so this flaw was a better, but still conservative, estimate of the length.

- A small flaw at the weld root cavity. This was modelled as a semi-elliptical flaw 70 mm long by 3 mm and by 4 mm deep (2 cases). The weld cavity was 230 mm long, so this flaw was a better, but still conservative, estimate of the length.

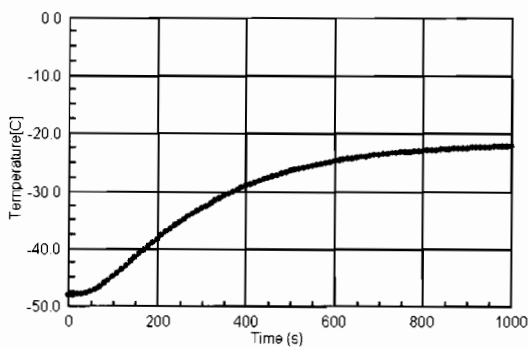
**Figure 6.20 Temperature at tubesheet to channel weld for Case 1**

6.39 Figure 6.20 and Figure 6.21 show the results for the two cases modelled. From the graphs it can be seen that the time taken for the temperature of the tubesheet to channel weld to increase to 20°C greater than the channel is of the order of three and a half to seven minutes.

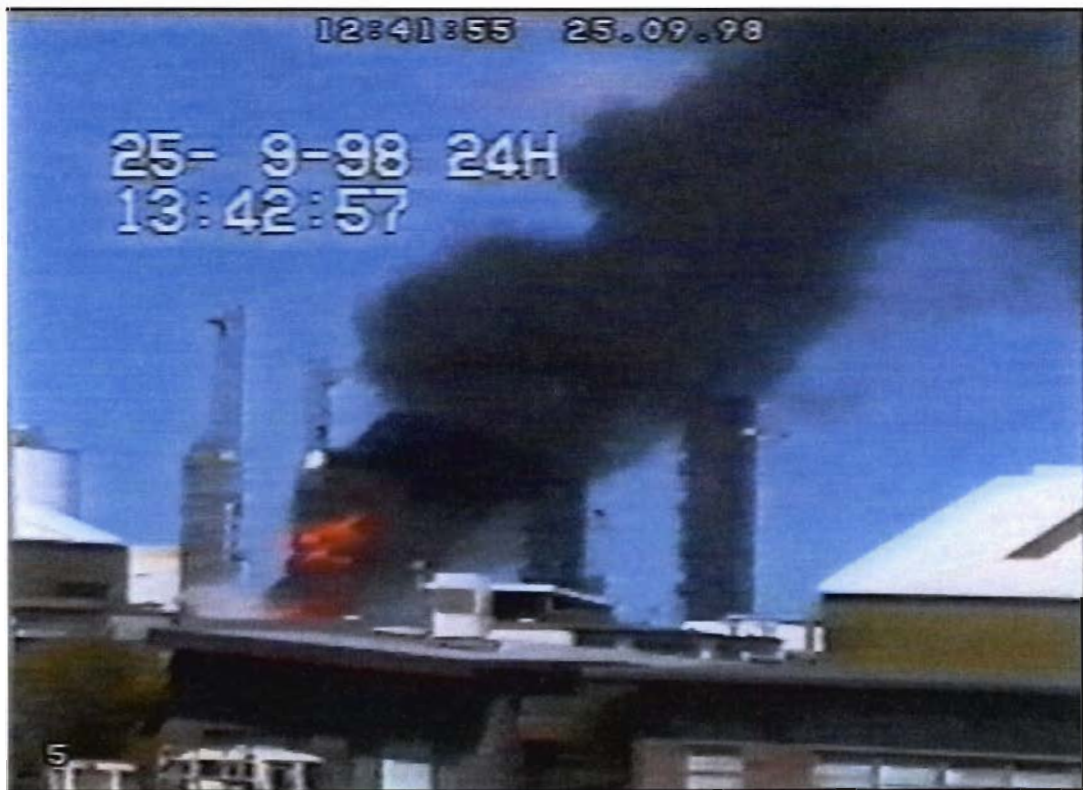
*Figure 7.1 The first film of the fire, taken at 12:41:55*

- 7.13 Around this time (12:41 according to the video time stamp), the guards in the main entrance guard house repositioned two of their security video cameras so as to video tape the fire. The first video recorded picture of the fire (Figure 7.1) shows a red yellow flame with a height of between 15 and 20 meters and a thick cloud of black smoke drifting in a south-easterly direction. The relevant time stamp on this figure and subsequent figures depicting photographs from the security video camera, is the one appearing at the very top of the figure.
